TECHNICAL REPORT REMR-CO-3

CASE HISTORIES OF CORPS BREAKWATER
AND JETTY STRUCTURES

Report 4

PACIFIC OCEAN DIVISION

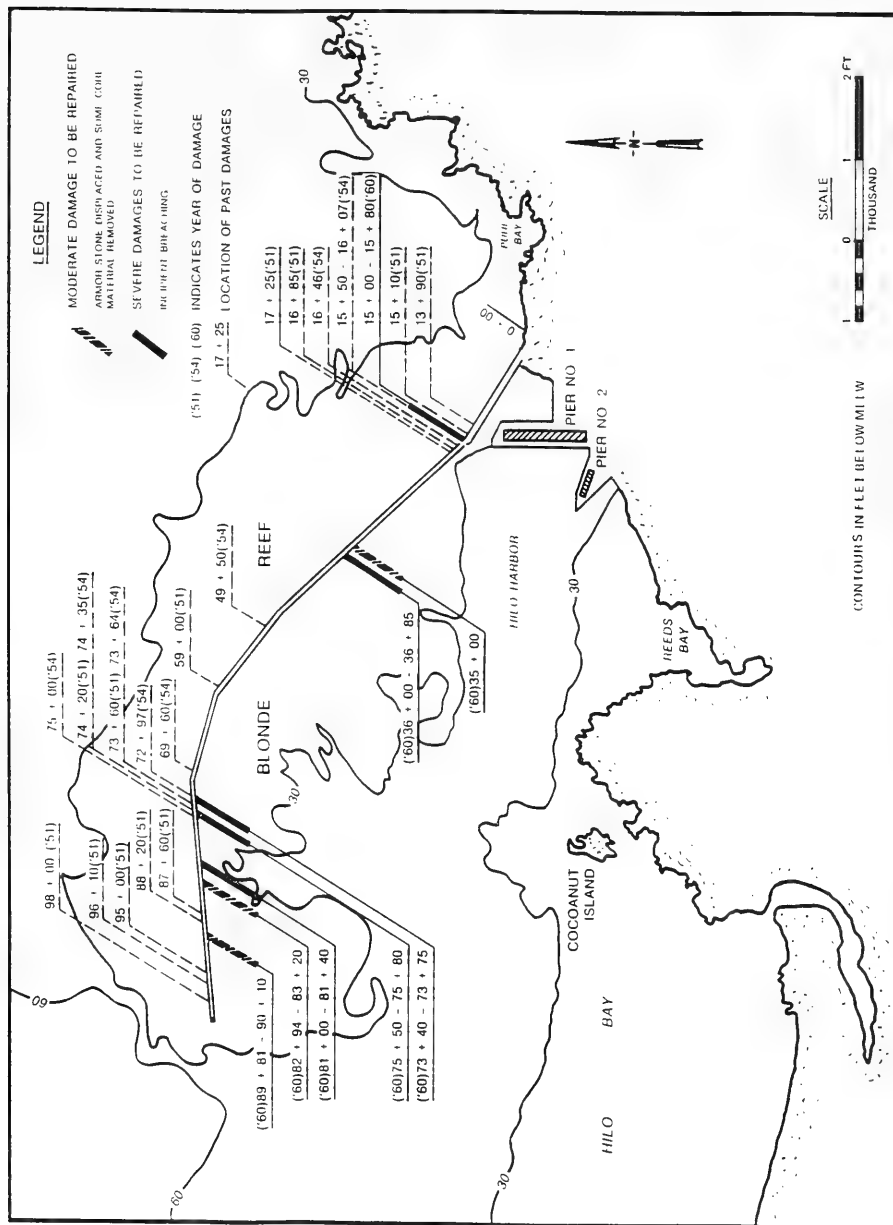
1960	The tsunami of 1960 caused breakwater damage (Figure 4), but it was not as severe as that sustained by the 1946 tsunami. Less severe damage was attributed to the direction of wave attack. The 1960 approach was less direct than that of 1946; therefore, wave energy reaching the structure was less than what had occurred in 1946. Between 1946 and 1960 average annual maintenance costs were \$25,000. It was thought that the 1946-1948 repair work did not key the replacement armor into the existing structure, thus resulting in weaker cross sections in these repair areas.
1965	Storm waves of February 1965 caused additional damage at sta 15+00, 36+30, 73+40, 83+00, and 90+00.
1967	Between the 1960 and the 1967 tsunami, no repair work was done due to the possibility of total rebuilding of the breakwater as one leg of a proposed tsunami barrier for Hilo Harbor. The average annual cost of structure maintenance had been \$43,900 for the first 37 years of the project.

Figure 4. Hilo Breakwater damage summary, 1951-1960

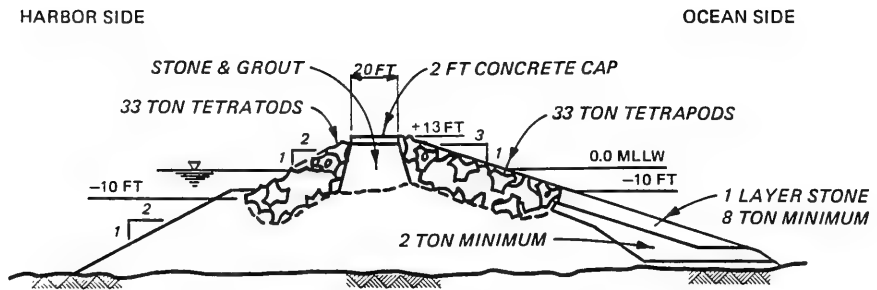
Figure 7. Kahului breakwater repairs of 1956
(typical cross section)

1956	<p>During 4-7 March 1954 a north swell with hindcasted deepwater significant wave height of 26 ft caused estimated breaking wave heights of 34 ft at the structures. Damage was extensive to 185 ft and 300 ft of the seaward ends of the east and west breakwaters, respectively. Capstone and slope stone (8 tons) were dislodged, and core material was washed down to an elevation of approximately -6.0 ft mllw. This damage initiated action to begin basing repair work on current design criteria rather than simply restoring damaged sections to their original conditions.</p> <p>Repairs of damage caused by the March 1954 storm were completed (Figures 5 and 7). Head repairs consisted of a double layer of 33-ton unreinforced tetrapods on a 1-V:3-H seaward slope and a 1-V:2-H landward slope. Two layers of tetrapods also were extended 250 ft down the sea side of the west breakwater trunk, and the core of both was capped with 2 ft of concrete.</p> <p>A total of 400 tetrapods was placed. To prevent encroachment of the structures on the entrance channel, the breakwaters were shortened slightly, and a 1-V:2-H slope was used on the inboard quadrant of the armor wraparound on the breakwater heads. The total cost of repairs was \$1,200,000.</p>

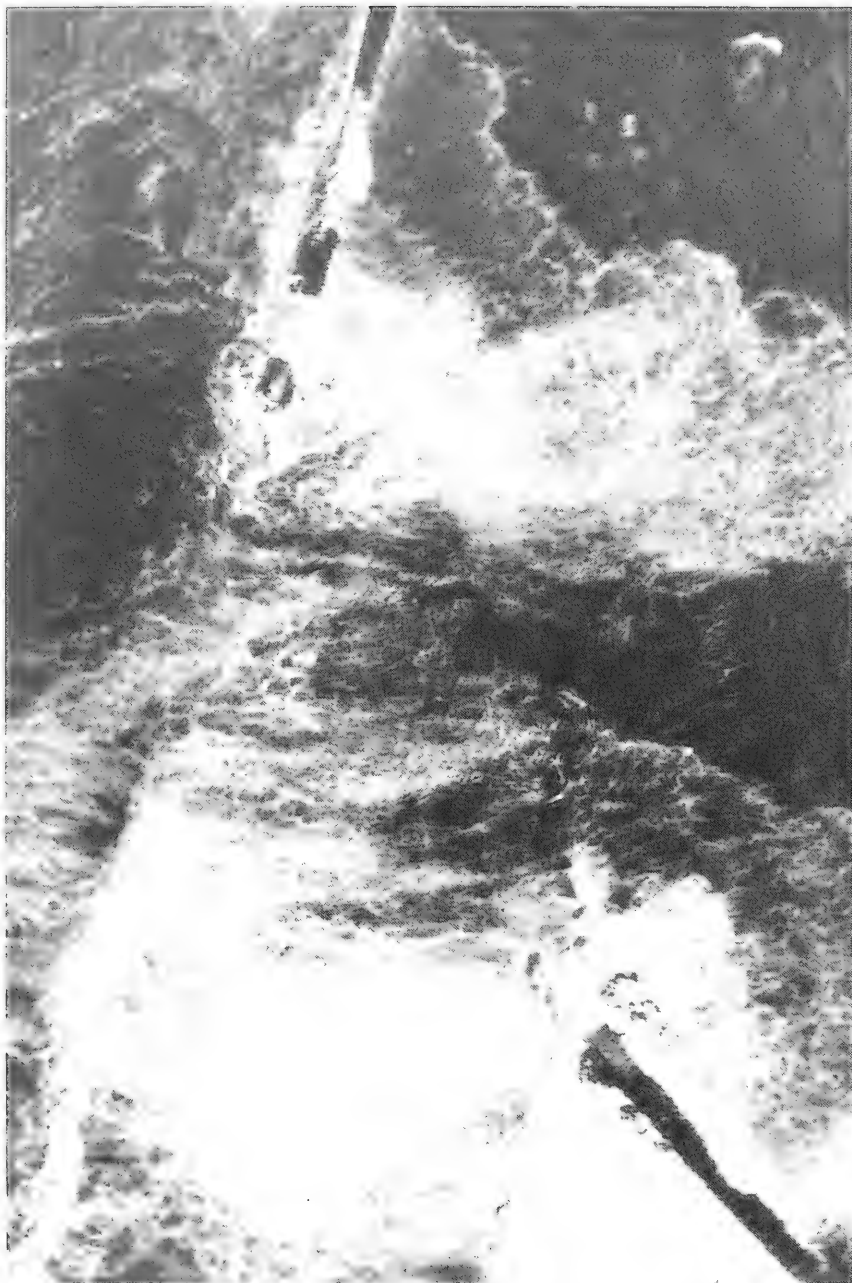
Date(s)	Construction and Rehabilitation History
1958	A storm (Figure 8) with estimated breaking wave heights at the structure of 25 ft caused severe damage to seaward ends of both breakwaters. The east breakwater was breached for a length of 154 ft in the original armor stone-tetrapod transition area, and at least six tetrapods were displaced from the head. On the west breakwater all the tetrapods (approximately 60 units) from the harbor-side quadrant of the head were swept away. The west breakwater's 1-V:2-H harbor-side slope appeared to be a major design deficiency.
1959	Stopgap repairs of damage from the November 1958 storm were completed, and design analysis for a major rehabilitation was initiated. These repairs consisted of construction of a heavy monolithic concrete cap (east breakwater, \$275,000) and placement of the heaviest available armor stone (12-ton minimum) on the seaward slope.

Figure 8. Kahului breakwater during storm of 22 November 1958

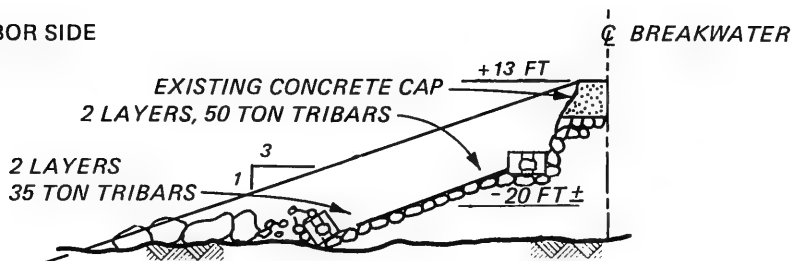
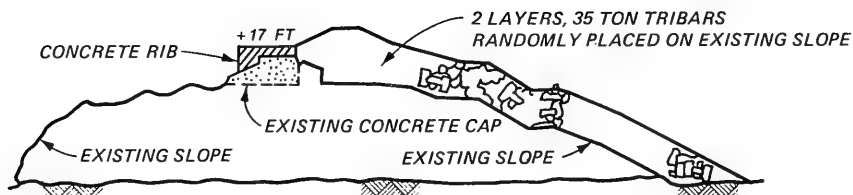
Figure 9. Kahului breakwater repair, 1966

a. Tribar repairs to inboard quadrant of head sections

b. Repair of sea-side slope of east breakwater head

1965	During 2-3 February, 1 month after awarding the tribar-placing contract, a storm with hindcasted deepwater wave heights of 27 ft and period of 17 sec caused damage to the heads of both breakwaters.
1966	Major rehabilitation (Figures 5 and 9(a,b)) consisted of repair of both breakwater heads and the first 355 ft shoreward of the east breakwater head. On the inboard quadrants of the breakwater heads, two layers of 35-ton tribars were placed over the lower third of the side slope, and two layers of 50-ton tribars were placed over the upper two-thirds. Two layers of 35-ton tribars were placed on the sea-side slope of the east breakwater head and buttressed against the concrete rib cap constructed on the crest; 827 and 181 35-ton reinforced tribars were placed on the east and west breakwaters, respectively; and 43 and 173 50-ton reinforced tribars were placed on the east and west breakwaters, respectively. Except for the concrete rib cap, all repair work was model tested (Jackson 1964). The total cost of repair work was \$1,560,000.

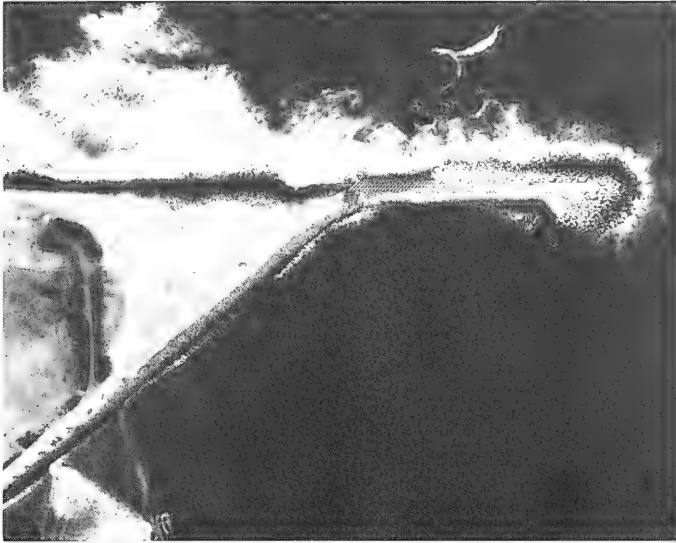
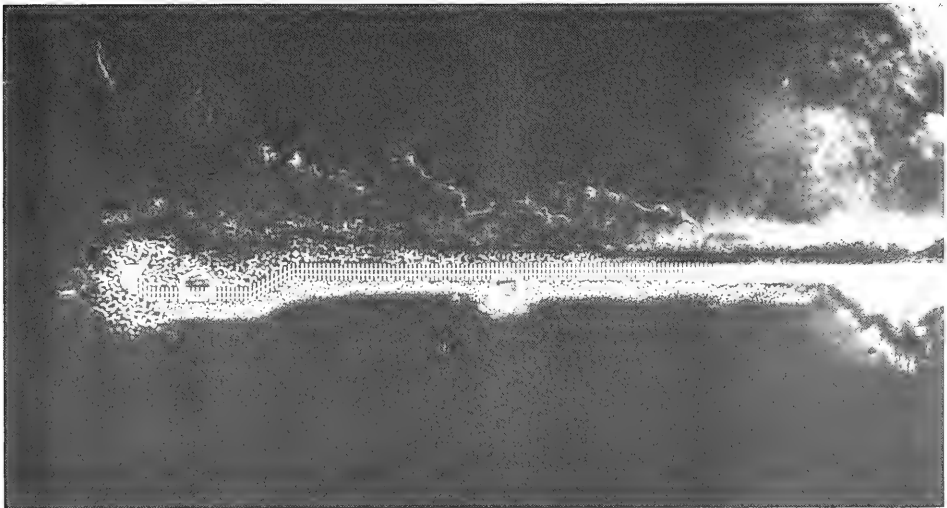
Figure 11. Aerial photographs of the Kahului breakwater, 1984

a. West breakwater

b. East breakwater

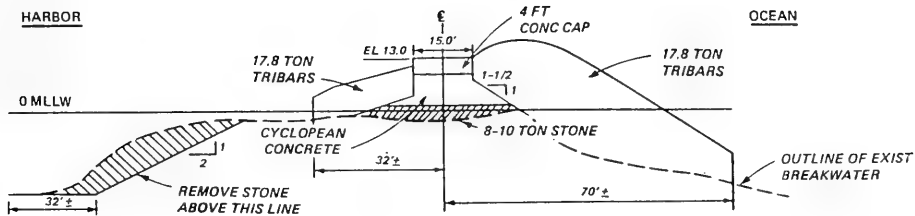
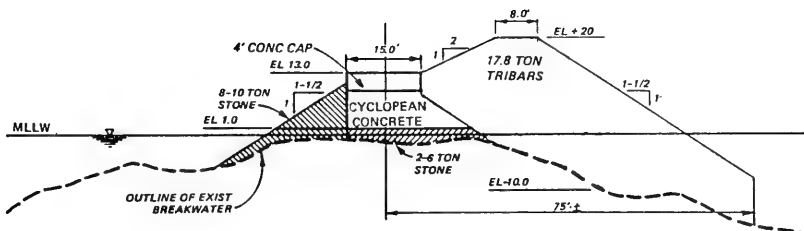
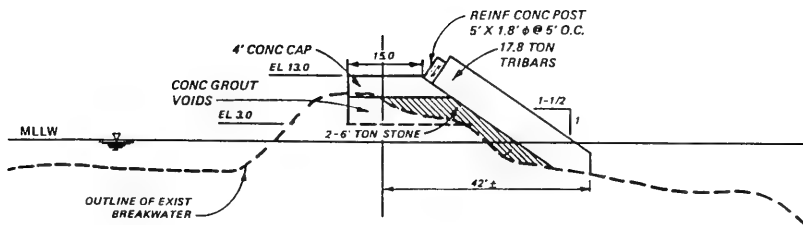
Date(s)	Construction and Rehabilitation History
1926	The original Corps-constructed (Figure 15) 2,150-ft-long rubble-mound breakwater was completed (construction started in 1922). It consisted of one-layer 8-ton keyed and fitted armor stone over core stone (500 lb and less) with 1-V:1-H slopes and a 15-ft-wide crown at +11.0 ft mllw. Except for severe wave action, it was considered to be a satisfactory empirical design cross section.
1927- 1953	Minor repair work was done at various times during this period. In 1931 114 stones were reset, and 3,153 tons of stone and concrete blocks were placed (no details available) at a cost of \$46,040. In 1930, 1932-37, 1945, 1951, and 1952, 1,998 tons of stone were used in repair work at a total cost of \$78,285. Details of the repair work were not found.
1954- 1957	The breakwater was severely damaged as the result of a storm in 1954 (hindcasted depth-limited breaking wave height of 24 ft at structure) which destroyed the head, washed 100 ft of core stone shoreward, and settled capstone to an elevation of a few feet below mllw with little lateral movement. Storm waves displaced armor stone and exposed and removed core material between sta 17+50 and sta 20+45 in 1956. Observed wave heights of 16 ft at the breakwater in September 1957 caused additional armor stones and core displacement between sta 16+00 and 20+45 and displacement of a few armor stone and core exposure between sta 14+00 and sta 16+00. Hydrographic and topographic surveys of January 1958 revealed that Hurricane Nina (depth-limited breaking waves at structure on 1 and 2 December 1957) displaced a few armor stones and exposed core material on the sea-side slope between sta 14+00 and sta 15+00. It also caused settling and raveling of all armor stone on the crown and sea-side slope between sta 15+00 and sta 20+20, resulting in an exposed core and large voids between armor stones and all armor stone and core above mllw (sta 19+25 to sta 19+50 and sta 20+20 to sta 20+45) which was displaced shoreward.

Figure 16. Typical cross sections for 1959 repair of Nawiliwili breakwater

1958- 1959	The head was rebuilt 100 ft landward of the original head (new head at sta 20+45), and 500 ft of the adjacent trunk were repaired (Figure 16) at a cost of approximately \$1,000,000 (model tested by Jackson, Hudson, and Housley 1960). Additionally, 17.8-ton tri-bars were randomly placed in two layers on the sea-side slope of the head and uniformly placed in one layer on the sea-side slope

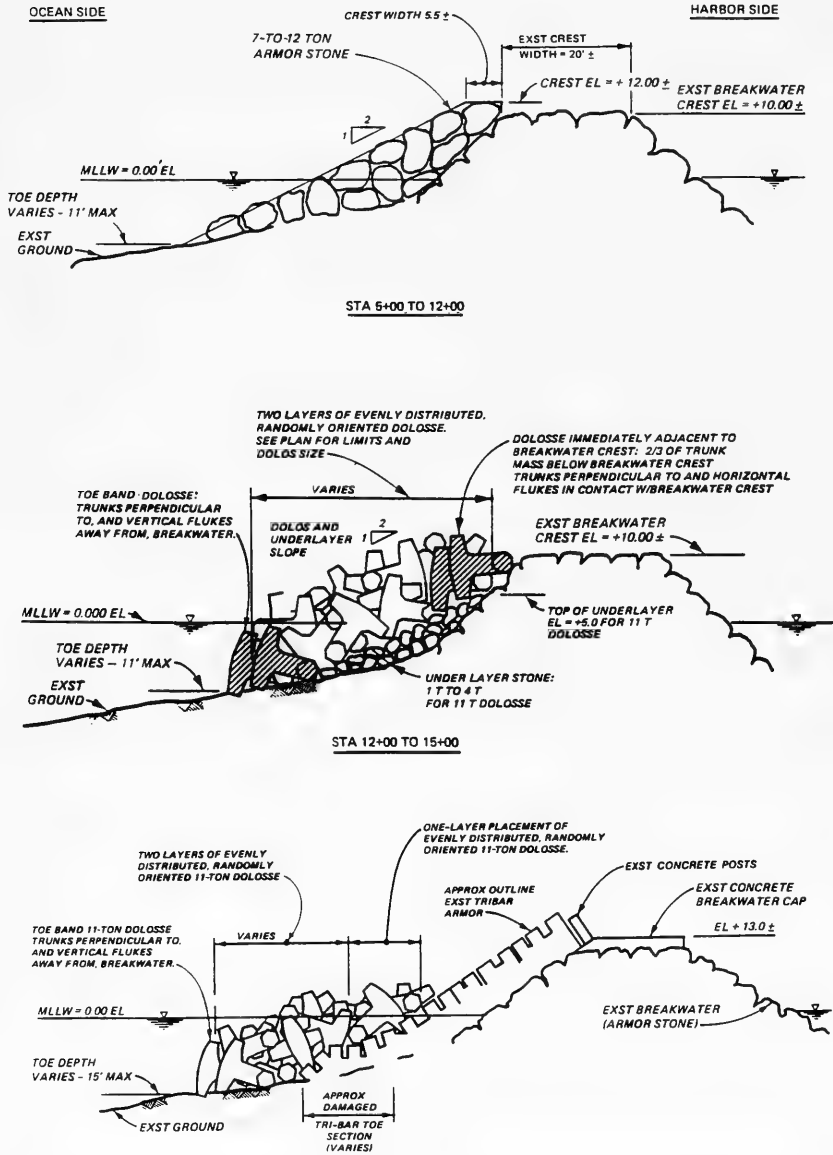
1968- 1976	After the storm of 16 June 1976, a field inspection and subsequent underwater inspection revealed 98 tribars broken in the one-layer tribar area, 43 above water and 55 below water. Damage was thought to be due possibly to slippage of the tribar toe. Model tests of the tribar rehabilitation had recommended the use of large buttressing stone, and there is no evidence of their existence on the tribar toe.
1977	The existing one-layer tribars and a 300-ft section of the sea-side slope shoreward of this area were repaired (model tested by Davidson 1978). Two layers of 11-ton unreinforced dolosse (485 units) were placed from the toe to approximately +5.0 ft mllw over the one-layer tribar area. Two layers of the same size unit (449 units) were placed from the toe to the crown on the sea-side slope of the trunk for a distance 300 ft shoreward of the tribar area. The design condition for the dolosse overlaying the tribar was a 12-sec, 19.4-ft breaking wave in an 18.5-ft water depth. On the other hand, the design condition for the dolosse overlaying the old existing armor stone was a 16-sec, 8.9-ft breaking wave in a 10-ft water depth. Portions of the sea-side slope shoreward of this area (approximately 300 ft) were repaired with one layer of 7- to 12-ton stone. This armor stone repair was not model tested. The total cost of repairs was approximately \$2,000,000. Typical cross sections of the repair areas are shown in Figure 17.

Figure 17. Typical cross sections for 1977 repair of Nawiliwili breakwater

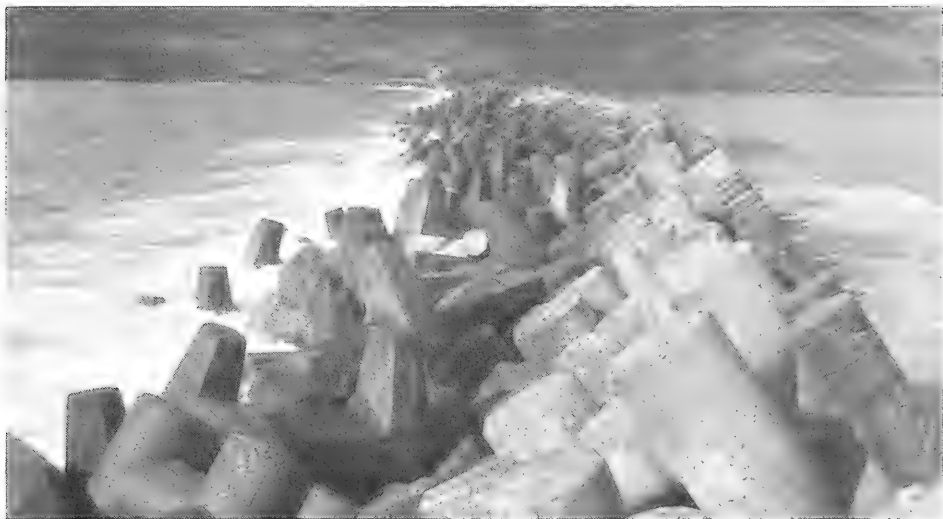
Date(s)	Construction and Rehabilitation History
1979	A field inspection on 26 September 1979 revealed a total of seven dolosse and five tribars broken above the still-water level (swl) between sta 16+00 and 20+00. No repair work was recommended.
1982	A reconnaissance report of August 27 expressed concern of the steep and degraded harbor-side slopes, and plans were initiated for rehabilitation work. Hurricane Iwa of November 23 reportedly produced depth-limited breaking waves at the structure. An inspection subsequent to the hurricane revealed considerable movement of concrete armor units which may have caused armor unit breakage below water. Nine dolosse and one tribar unit were found broken. Movement and shifting of stones on the crest of the breakwater were noted in three areas. Also, overtopping waves had displaced harbor-side stone and in one area had created a trough along the harbor-side toe.

1983	An underwater inspection was conducted on 9 August. This detailed inspection revealed that the underwater slope of the breakwater head was approximately 1V:1H, much steeper than it was thought to be. The inspectors recommended repair of the head to prevent a possible catastrophic failure of the head that could be initiated on steep underwater slopes.
1984	Figure 18 is a photograph of the breakwater taken from the head looking landward. A general design memorandum for the rehabilitation of the breakwater in 1985 was prepared. The proposed work was as follows: one and two layers of randomly placed dolosse on the sea- and harbor-side slopes of the head; one layer of 11-ton dolosse on the sea-side slope between stations 18+35 and 20+45; one layer of uniformly placed, 6.5-ton tribars on the harbor-side slope between sta 12+00 and 15+00; and concrete ribs on the crown between sta 12+00 and 20+45. Portions of this proposed work were model tested (Markle and Herrington 1983). The estimated first cost of this rehabilitation was \$3,500,000 based on January 1984 price levels.

Figure 18. View from head of Nawiliwili breakwater, July 1984

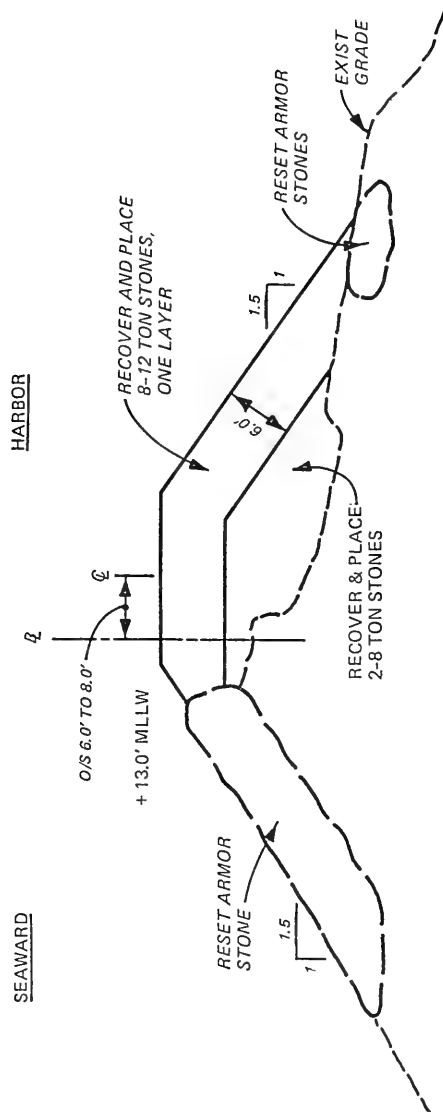
<u>Date(s)</u>	<u>Construction and Rehabilitation History</u>
1935	The 1,200-ft-long structure was completed as an extension to a privately constructed breakwater (Figure 21).
1982	Until damaged by Hurricane Iwa of November 23, the old 8-ton keyed-and-fitted armor stone structure had no repair history. The breakwater light at the seaward end had been damaged and repaired several times (Coast Guard cost) prior to its present destruction. The estimated 20-ft breaking waves at the structure first dislodged the stones on the inboard crest which eventually resulted in the total destruction of the outer 130 ft of the breakwater. Overtopping waves also displaced crest stone and exposed under-layer stone on a 150-ft length at the extreme root of the structure. Minor damage also was sustained along the inboard slope.
1984	The head was rebuilt, and the minor damage on the inboard slope was repaired at a cost of \$178,000. The breakwater was shortened to a total length of 1,126 ft. The outer 74 ft was abandoned. The repair was accomplished by resetting stone remaining on the structure and by retrieving stone from the harbor and replacing it on the structure using the old keyed-and-fitted construction (Figure 22). The crown elevation on the last 80 ft of structure was increased to +13.0-ft mllw. This was done to improve the stability of the inboard slope by decreasing wave overtopping. The root of the breakwater was not repaired.

Figure 22. Typical cross section showing 1984 repair of Port Allen breakwater head
